Quarter Report April-May 2025.

Rufford I.D: **45987-1**

The Title of Your Project: **Promoting Community-Led Afforestation for Soil Protection and Conservation of *Oreochromis esculentus* in Hombolo Dam, Dodoma, Tanzania.**

1.0 Reconnaissance Survey for the current status of the Hombolo Dam.

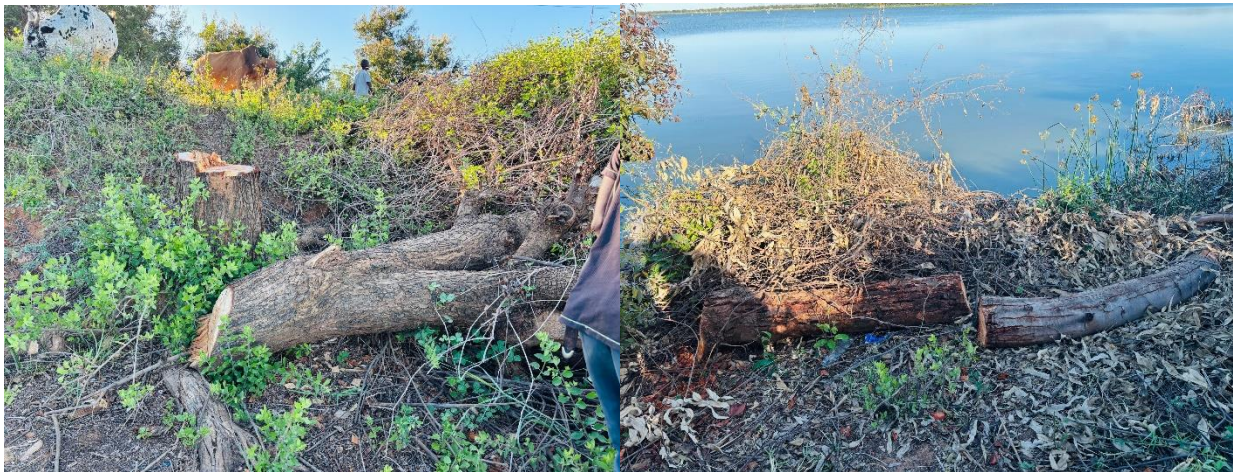
This involved establishing a clear baseline of the current condition of the dam and assessing the impacts it has been experiencing, in order to inform appropriate mechanisms for its restoration. The survey outlines the ongoing activities affecting Hombolo Dam, including the increasing rate of tree cutting along the dam's banks and shoreline. Many surrounding villages heavily overharvest these trees for firewood and construction purposes (Figure 01), contributing significantly to environmental degradation and reduced ecosystem stability.

Figure 01: Increase Deforestation of Trees surrounding the Hombolo Dam for Firewood and construction purposes. **Photo credit © Frank-UDOM 2025.**

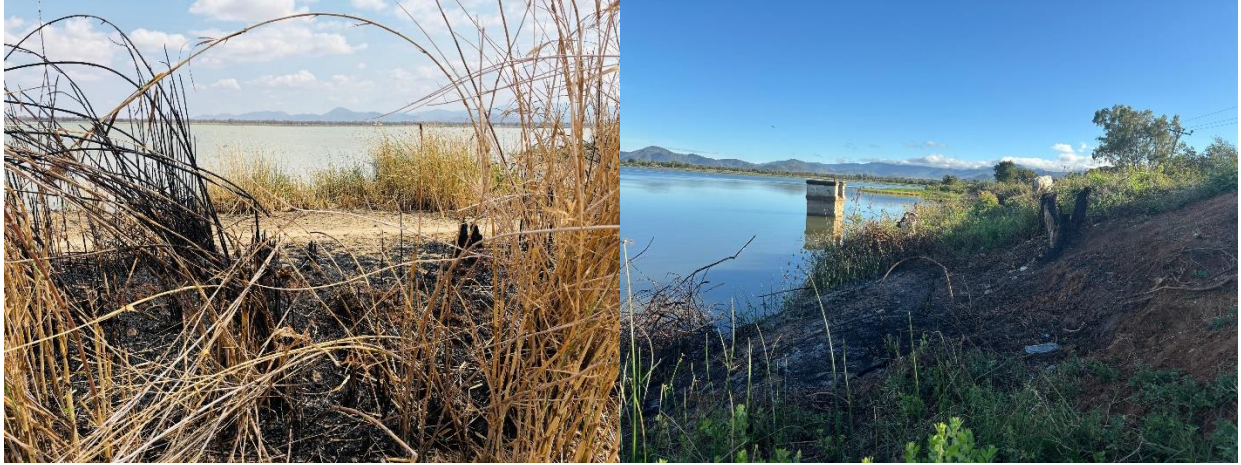
2.0 There has been a growing trend of clearing land through shrub burning and tilling along the shoreline surrounding Hombolo Dam, primarily to establish vegetable gardens and other agricultural activities for various purposes.

Figure 02: Burning of the shrubs surrounding the dam shoreline at Hombolo Dam. **Photo credit © Frank-UDOM 2025.**

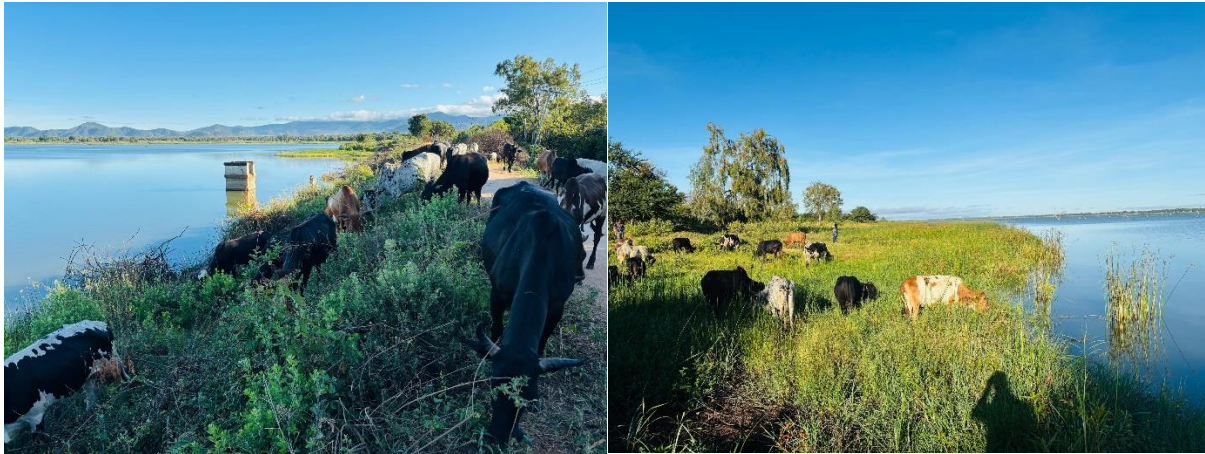
3.0 There has been a noticeable increase in livestock grazing around Hombolo Dam, with animals frequently accessing the water for drinking. This poses a significant concern for domestic water use in nearby villages and has intensified existing conflicts among grape farmers, vegetable growers, and fishers over declining water levels and increasing pollution.

Figure 03: Increasing numbers of livestock grazing along the shoreline of Hombolo Dam. **Photo credit © Frank-UDOM, 2025.**

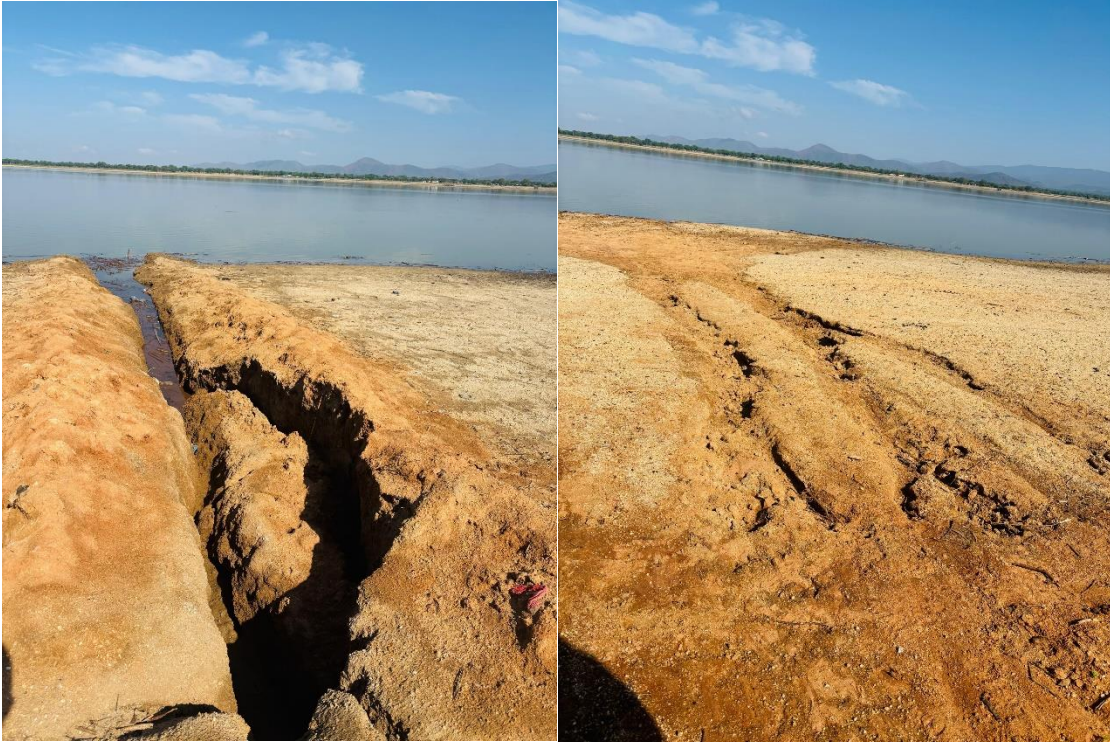
4.0 There has been an increase in the unregulated construction of water channels used to extract water from the dam for agricultural purposes. These channels have contributed to undesirable levels of erosion and siltation, accelerating sediment accumulation in Hombolo Dam and further degrading its ecological condition.

Figure 04: Unregulated construction of water channels used to extract water from the dam for agricultural purposes. **Photo credit © Frank-UDOM, 2025.**

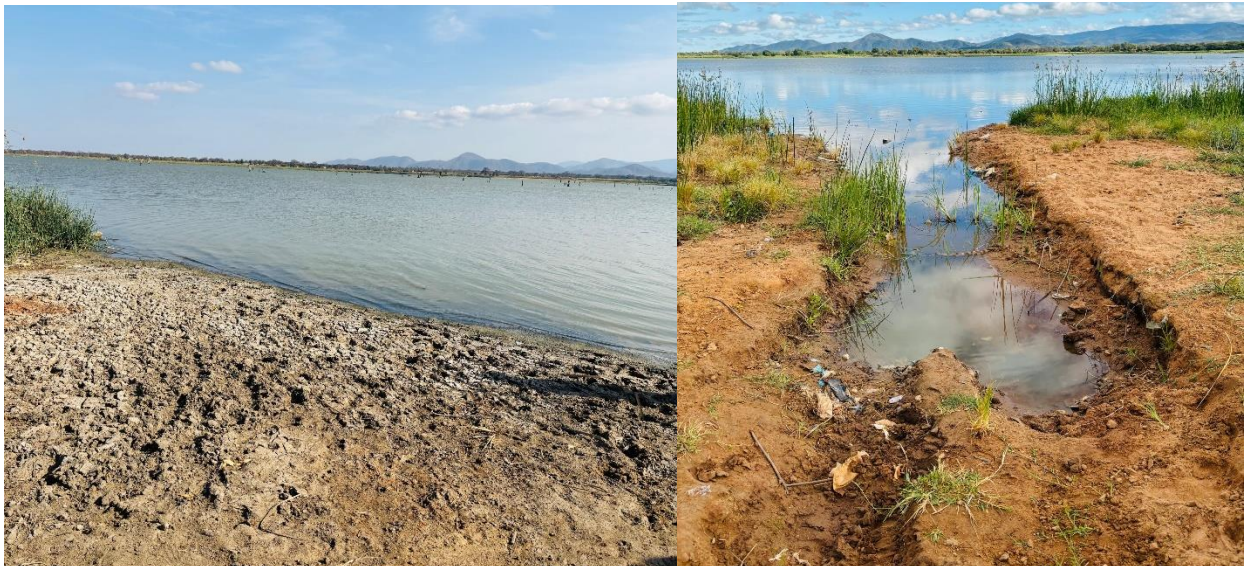
5.0 There has been a noticeable decline in water levels at Hombolo Dam, with the dam increasingly drying up. This is largely attributed to unsustainable multiple uses of the water resource, coupled with high rates of sediment deposition driven by shoreline tilling and rainfall runoff, which together reduce the dam's storage capacity and overall resilience.

Figure 05: Decline in water levels at Hombolo Dam, with the dam increasingly drying up. **Photo credit © Frank-UDOM, 2025.**

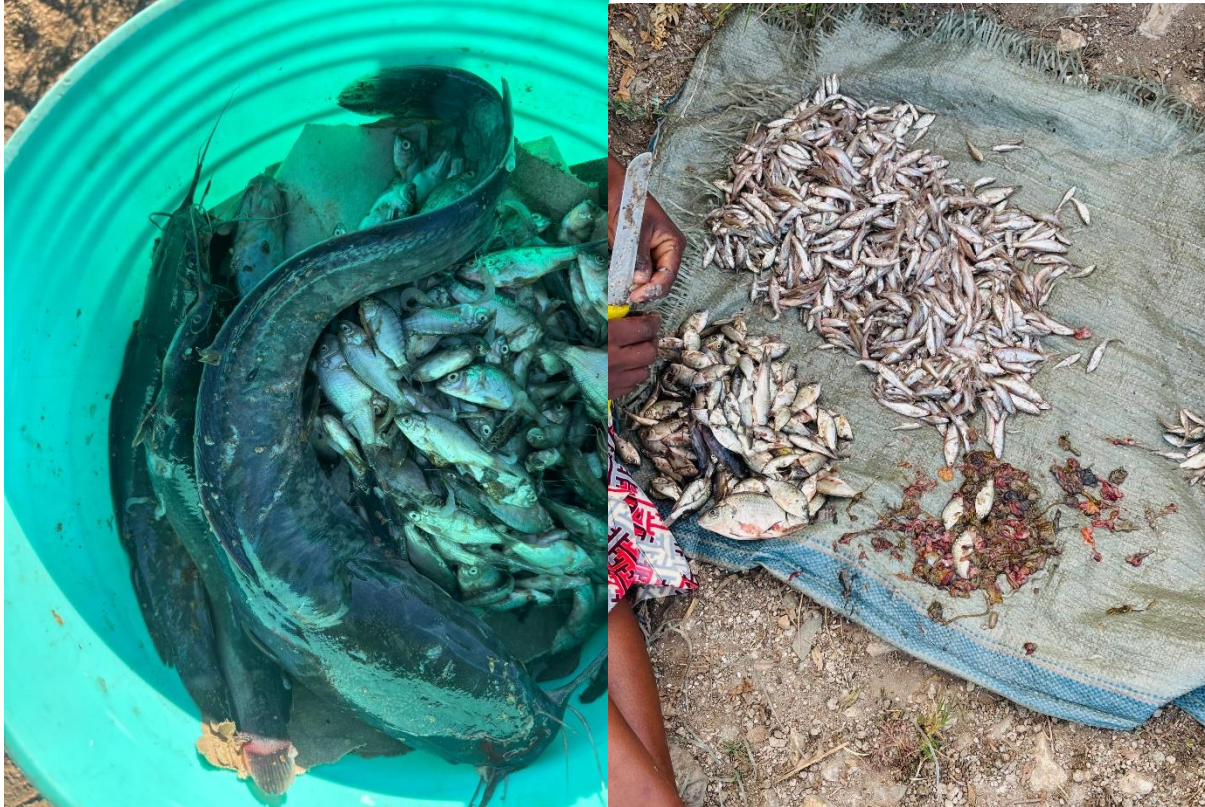
06. The survey also assessed current fishing activities at Hombolo Dam, including the types of gears used in relation to the size and species of fish caught (Figure 06). This provided insights into which species are being targeted for livelihoods, with particular attention to the exploitation patterns of *Oreochromis esculentus*.

Figure 06: Assessed current fishing activities at Hombolo Dam.
Photo credit © Frank-UDOM, 2025.
