## Project Update: January 2014

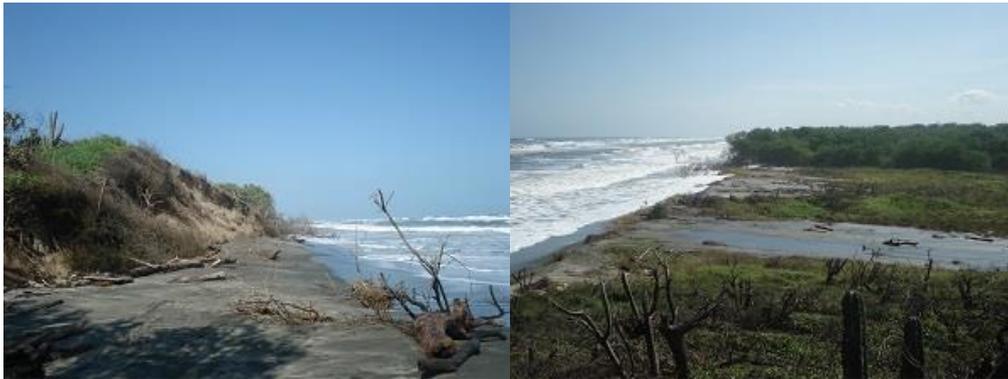
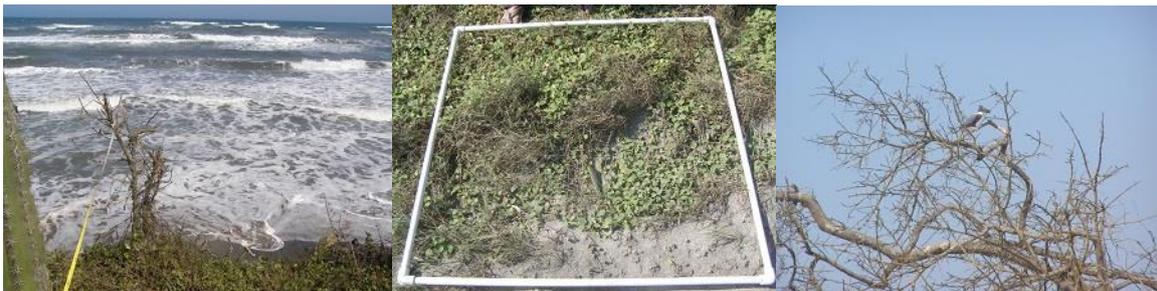
Preliminary data taken from the field as well as from imagery analysis indicate an overall erosion trend along the study site, with increasing erosion rates from east to west. In accordance, dunes height and distance from the shoreline are being controlled by coastline changes overtime. Likewise, vegetation associations depend on erosion magnitude. Common plant species found along beach profile transects are *Sporobulus virginicus*, *Pereskia colombiana*, *Capparis flexuosa*, *Cnidoscoulus urens* and *Paspalum vaginatum*.
