Project Update: November 2015

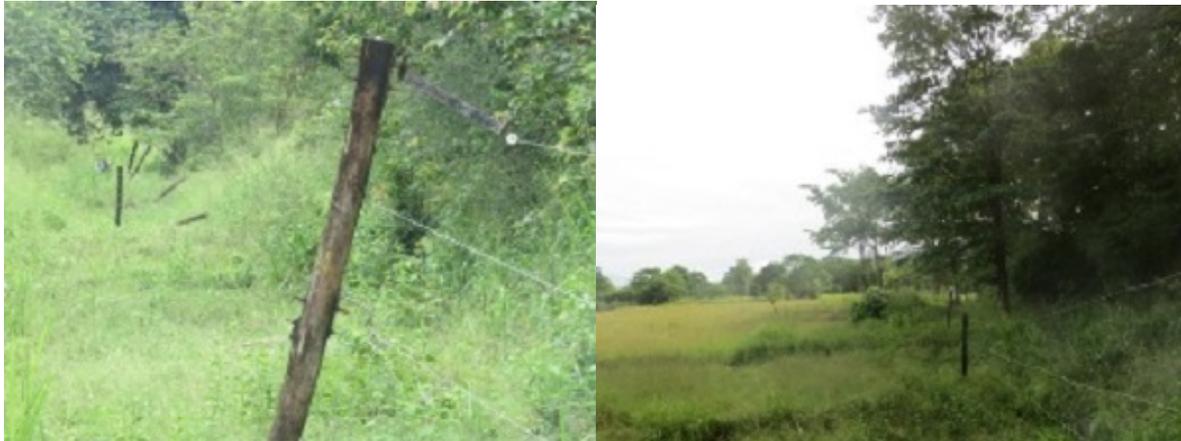
To study effectiveness of the park electric fence located at ecological (Pic. 1) and administrative (Pic. 2) boundaries, 1 km of fence stretches were selected for each. The condition of the fence, such as fallen posts, broken wires and touching of vegetation were recorded.

Pic.1-2: The park fence at an ecologically boundary and an administrative boundary.
