**RESTORATION OF MANGROVE FOREST AND IMPROVING THE
AWARENESS OF THE LOCAL COMMUNITIES ON THE PROTECTION OF
MANGROVE ECOSYSTEMS**

Nguyen Thi Thanh Thuy, Ha Le Thi Loc
Institute of Oceanography

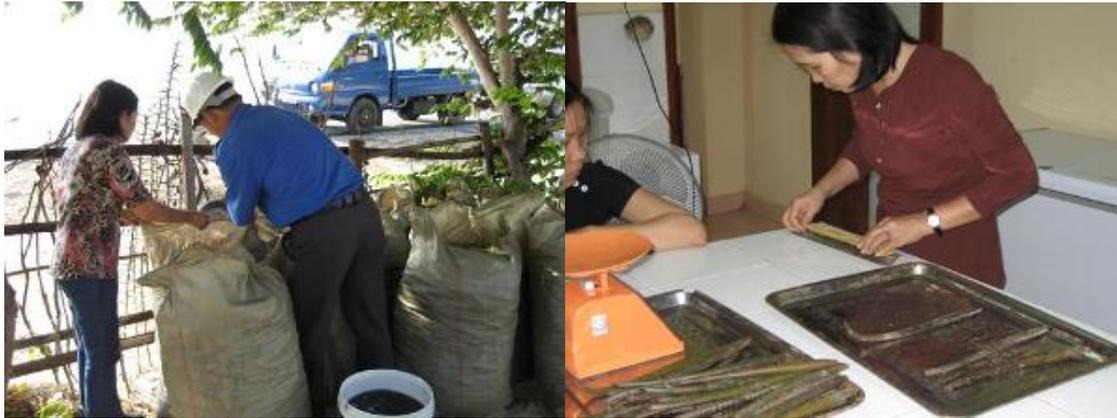
Photo 4. *Rhizophora apiculata* Bl. propagules were treated with chemicals and measured before replanting

The propagules were watered and kept under moisture condition until planted. Before planting, the propagules were pre-treated with the commercial pesticides and root growth promoting solution (Photo 4 – Appendix 1).

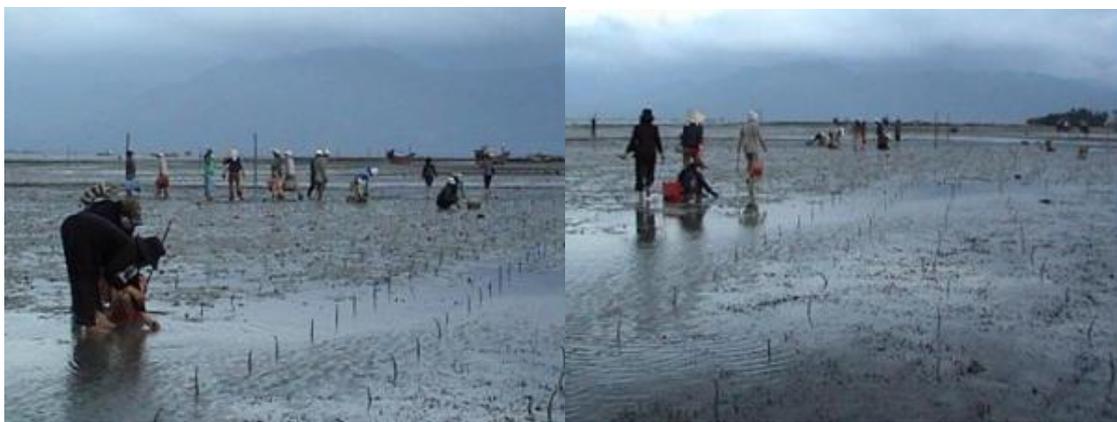
Photo 5. The local people participated replanting *Rhizophora apiculata* Bl. at new replanted area belonging to Tuan Le village, Van Tho commune, Van Ninh - Khanh Hoa

The density of *Rhizophora apiculata* Bl. propagules for replanting was 10,000 propagules/ha. The participators were trained theoretically in the workshop and practically on the field about techniques of planting and taking care of the propagules: two people were along together; one used a one meter wooden stick with one side pointed to make holes on the sea bottom and the other put the propagule in the hole and fixed it at 1/3 of the propagule. The gap between holes was 1 x 1 m (Photos 5 and 6- Appendix1).

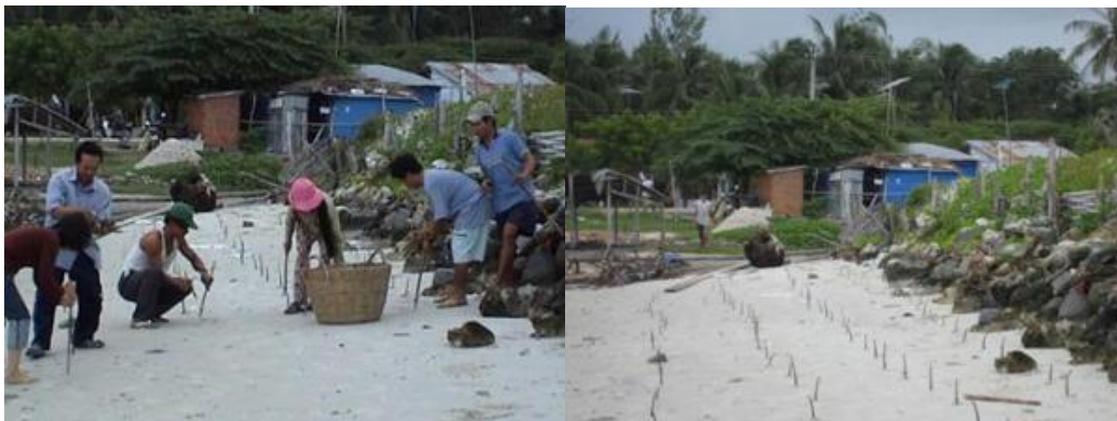
Photo 6. The local people participated replanting *Rhizophora apiculata* at shrimp pond banks belonging to Tuan Le village, Van Tho commune, Van Ninh - Khanh Hoa

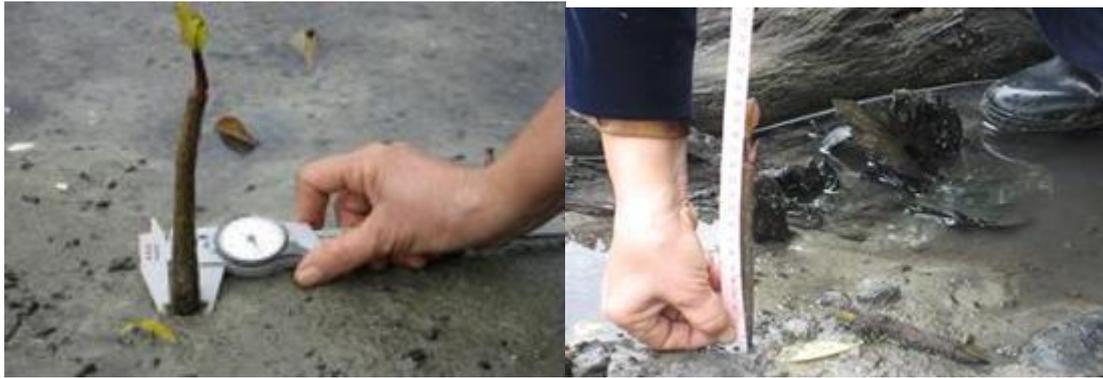
Photo7. Measuring monthly diameter and height of *Rhizophora apiculata* Bl.

After planting, the growth rate and survival rate of *Rhizophora apiculata* Bl. propagules were monthly recorded by the working team and the local participators (Photo 7- Appendix 1).
