## **Project Update: February 2022**

**Activity conducted:** Between 12<sup>th</sup> January – 7<sup>th</sup> February 2022, we did an electrocution survey in the foraging areas of bearded vulture (BV) and mountain hawk-eagle (MHE) based on their tracking data from our previous study. We overlaid the home range polygons of BV and MHE from the GPS tracked birds (total 14 birds) on Google Earth to identify areas to be surveyed. Based on the movement data, we focused our work on the Kaski (Thoolakharka, Dhampus, Ghandruk, Tolka, Bhadaurey, Panchase, Dipang, Puranchaur), Parbat (Deupur, Chitre) and northern belt of Syanja (Khamaley, Rapu) districts that lie in and around the periphery of Annapurna Conservation Area (Fig 1). Surveyed areas are the core ranges of bearded vulture in Nepal as shown from the movement study; as well as these areas overlap with the territories of mountain hawk eagle.

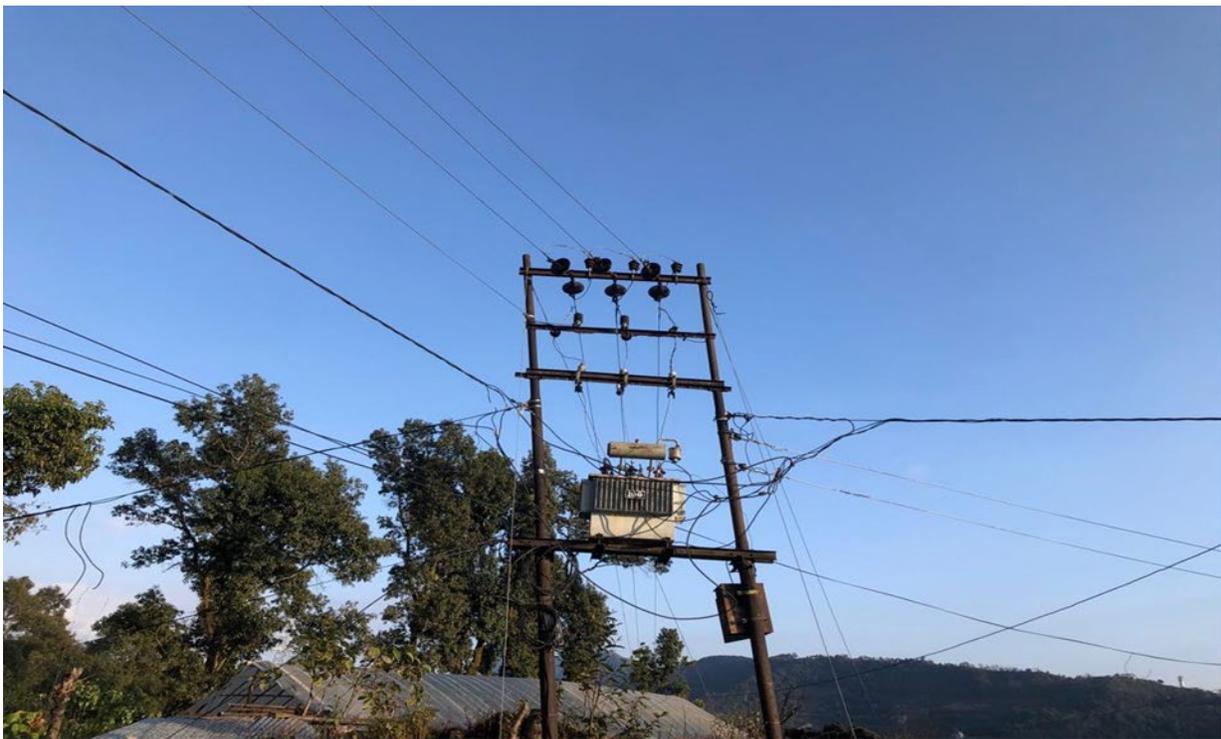
Photo: Horizontal configuration with a "Simple H-frame" with a ceramic insulator arranged in "strain insulator" type with an external transformer

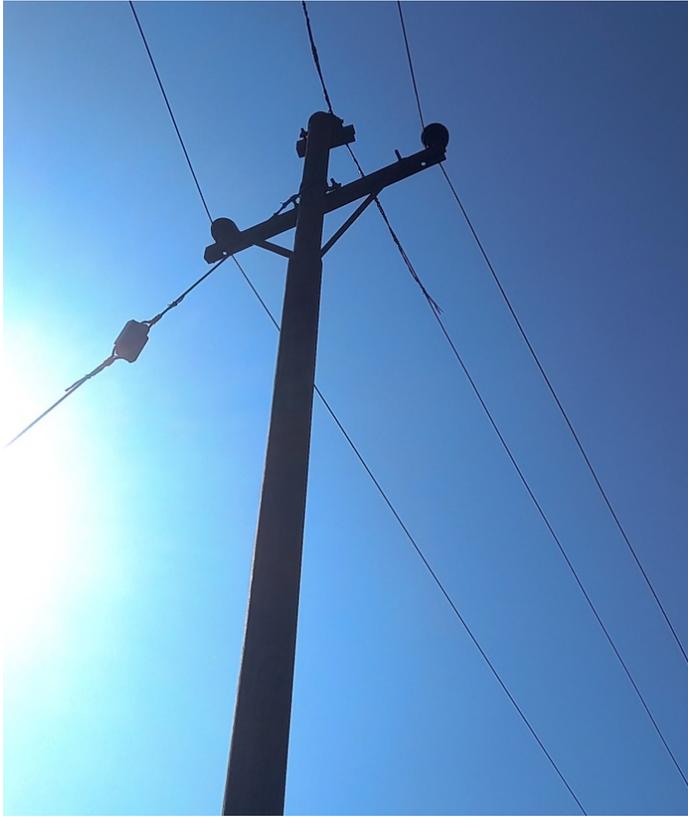
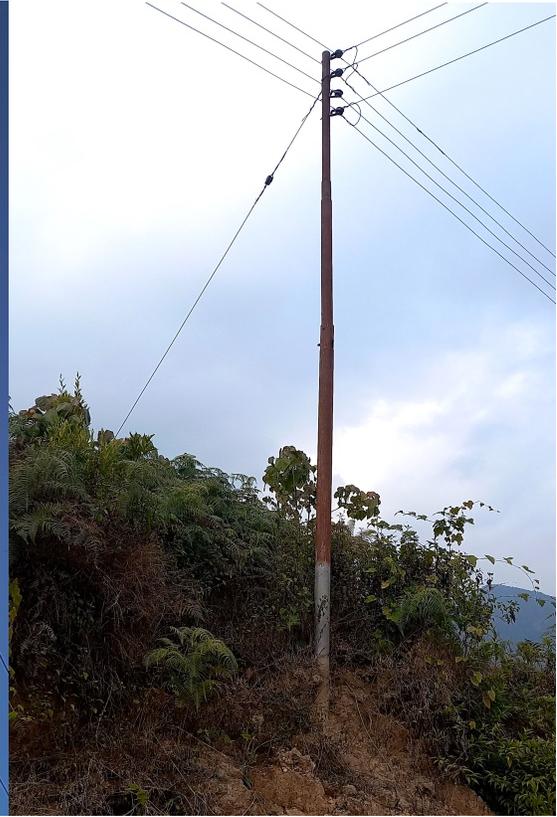
Photo: Triangular configuration with "Simple I" cross-shaped having a cross arm made of metal (left) and vertical configuration with an absence of cross-arm materials (right)

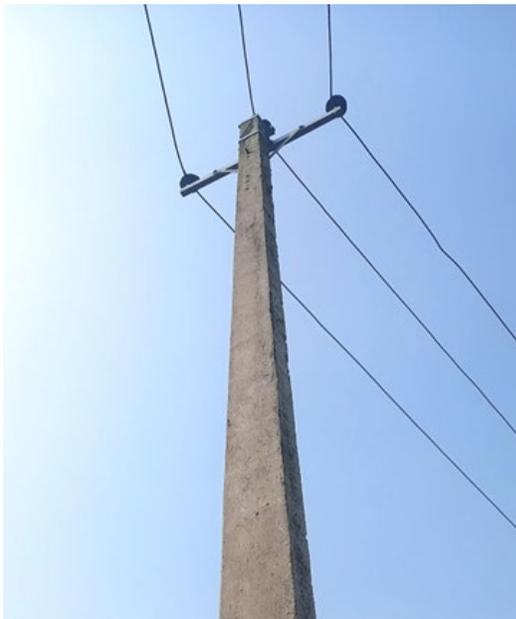
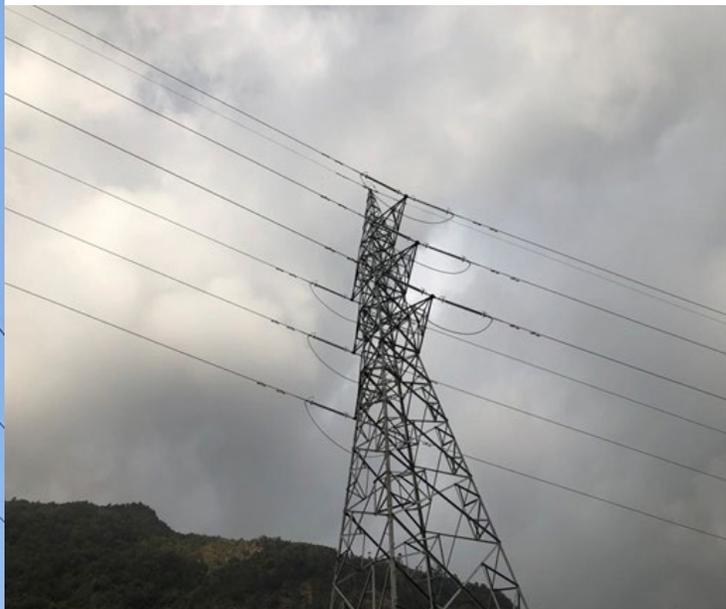
Photo" Power poles with a concrete pole material (left) and high-tension lines with a vertical configuration of "Double circuit, angled struts"

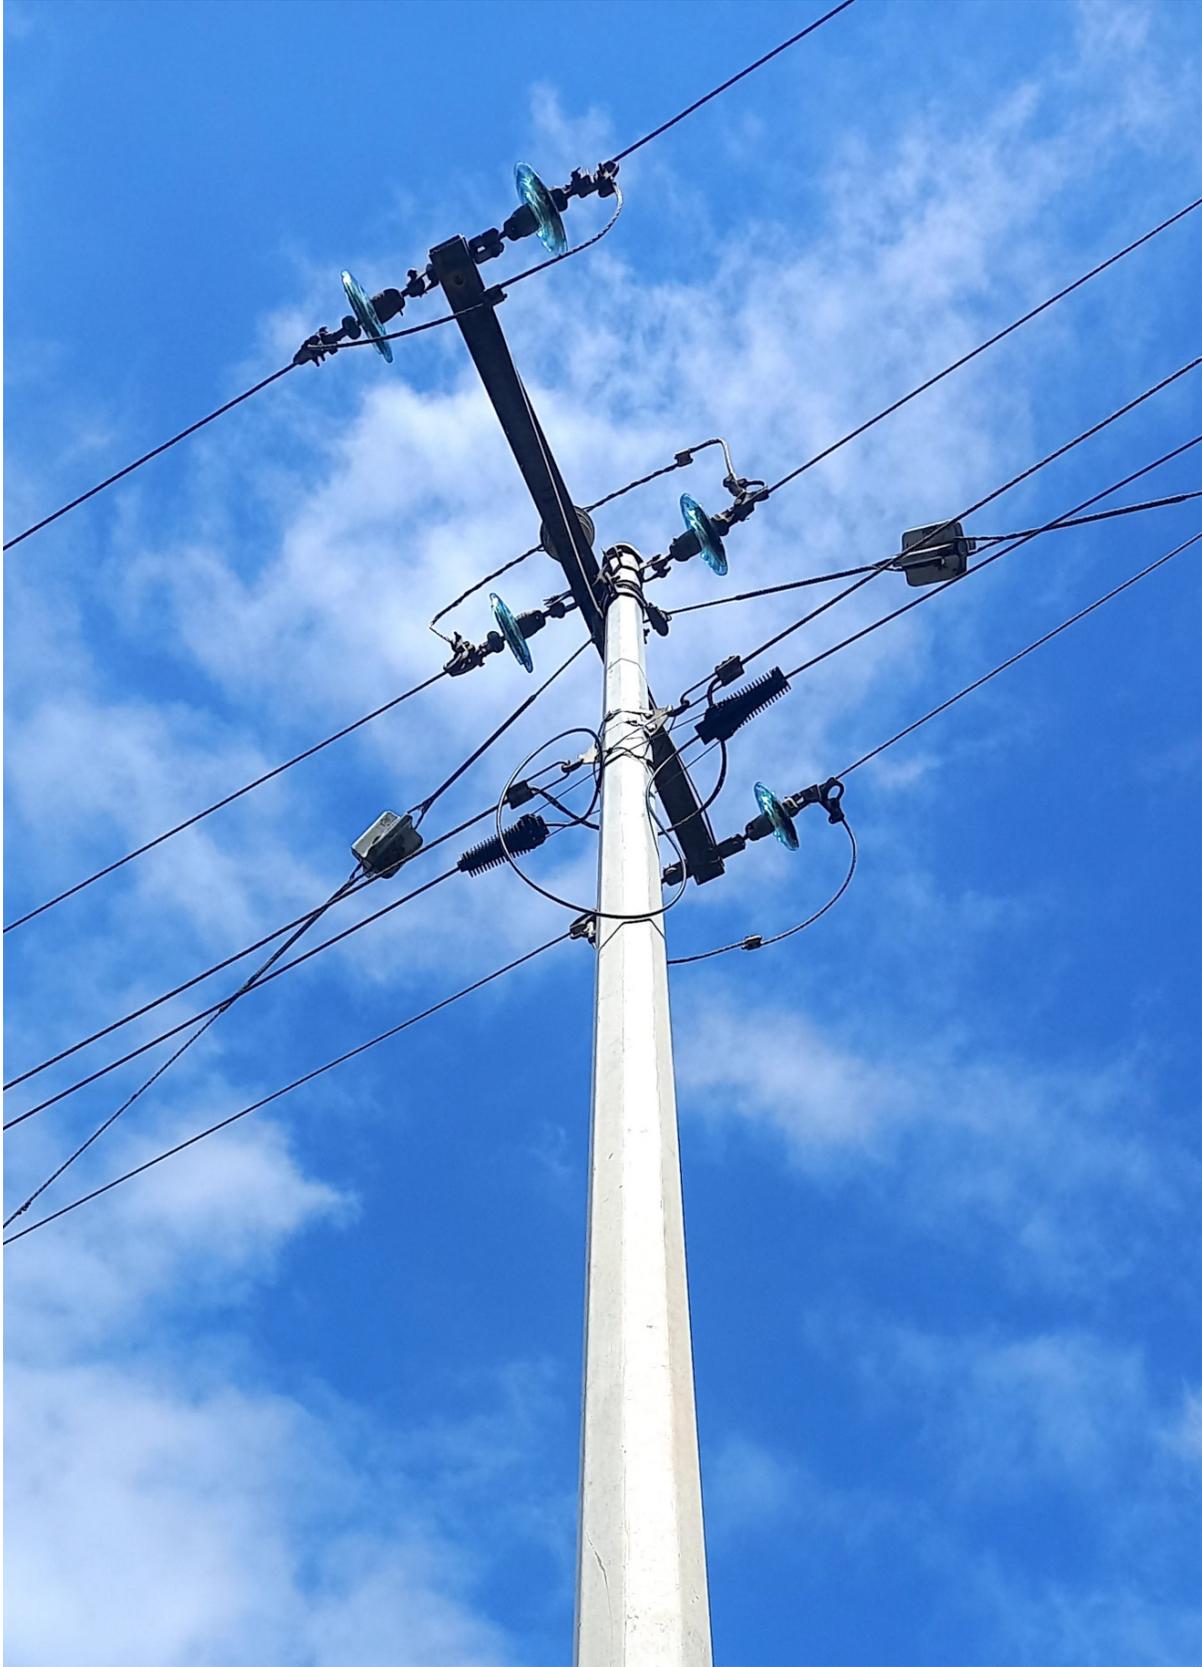
Photo:" Simple I" type of Horizontal configuration with a glass insulator "strain insulator" arrangement having 3 jumpers about the insulators

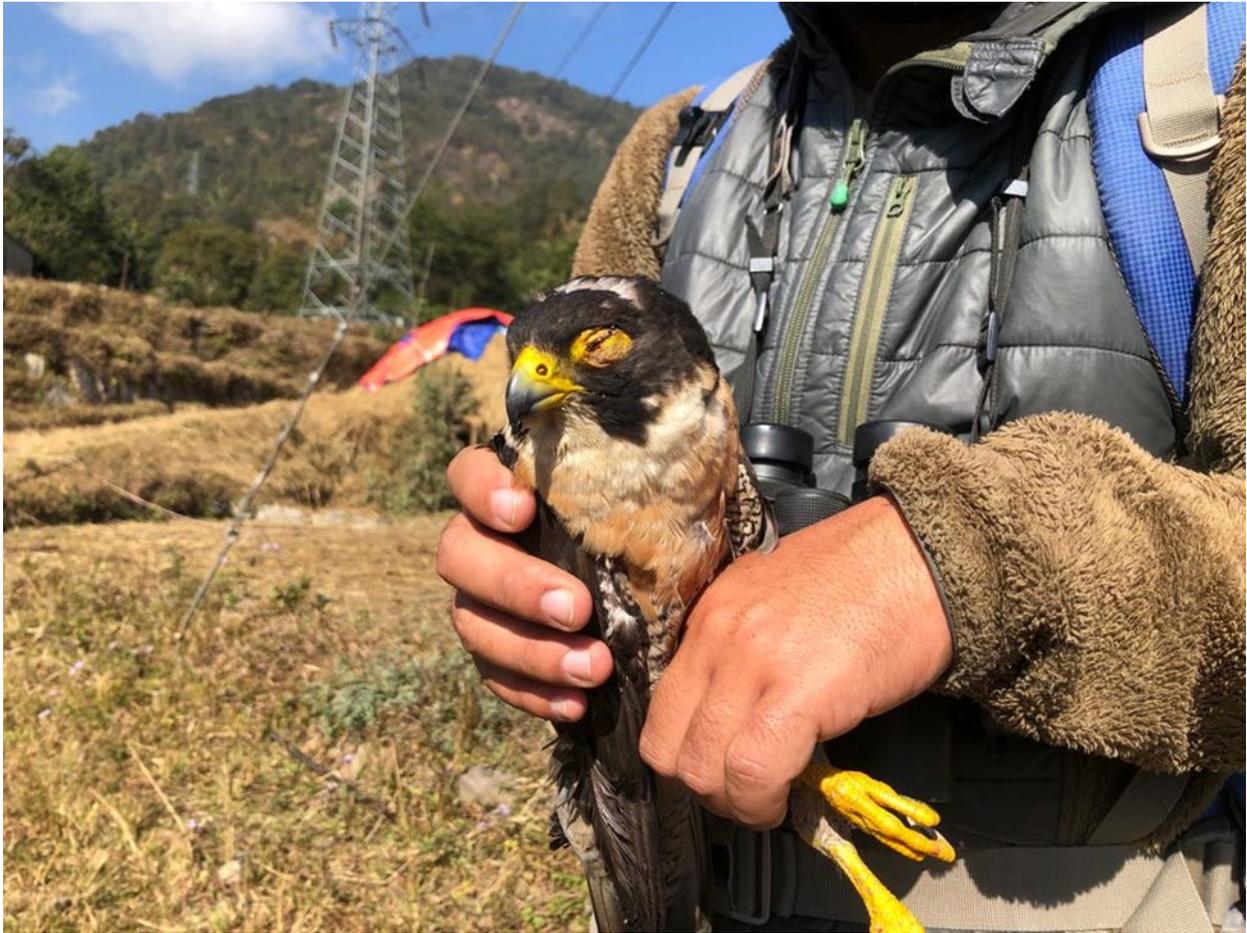
Photo: Injured Peregrine Falcon by electric poles found during the survey period in lower Dhampus

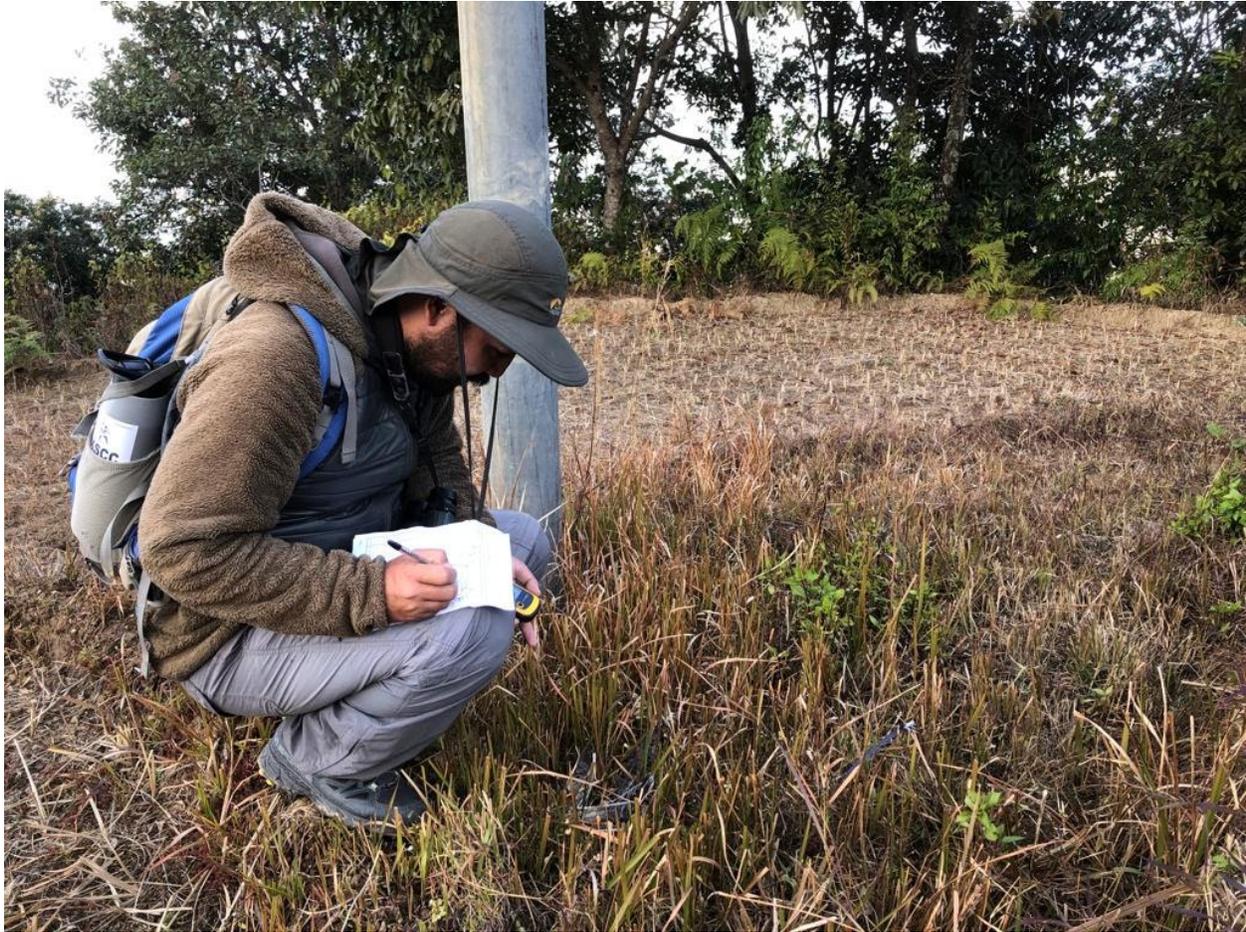
Photo: Recording the decayed carcass of the large, billed crow situated under the electric poles in Bhadaurey

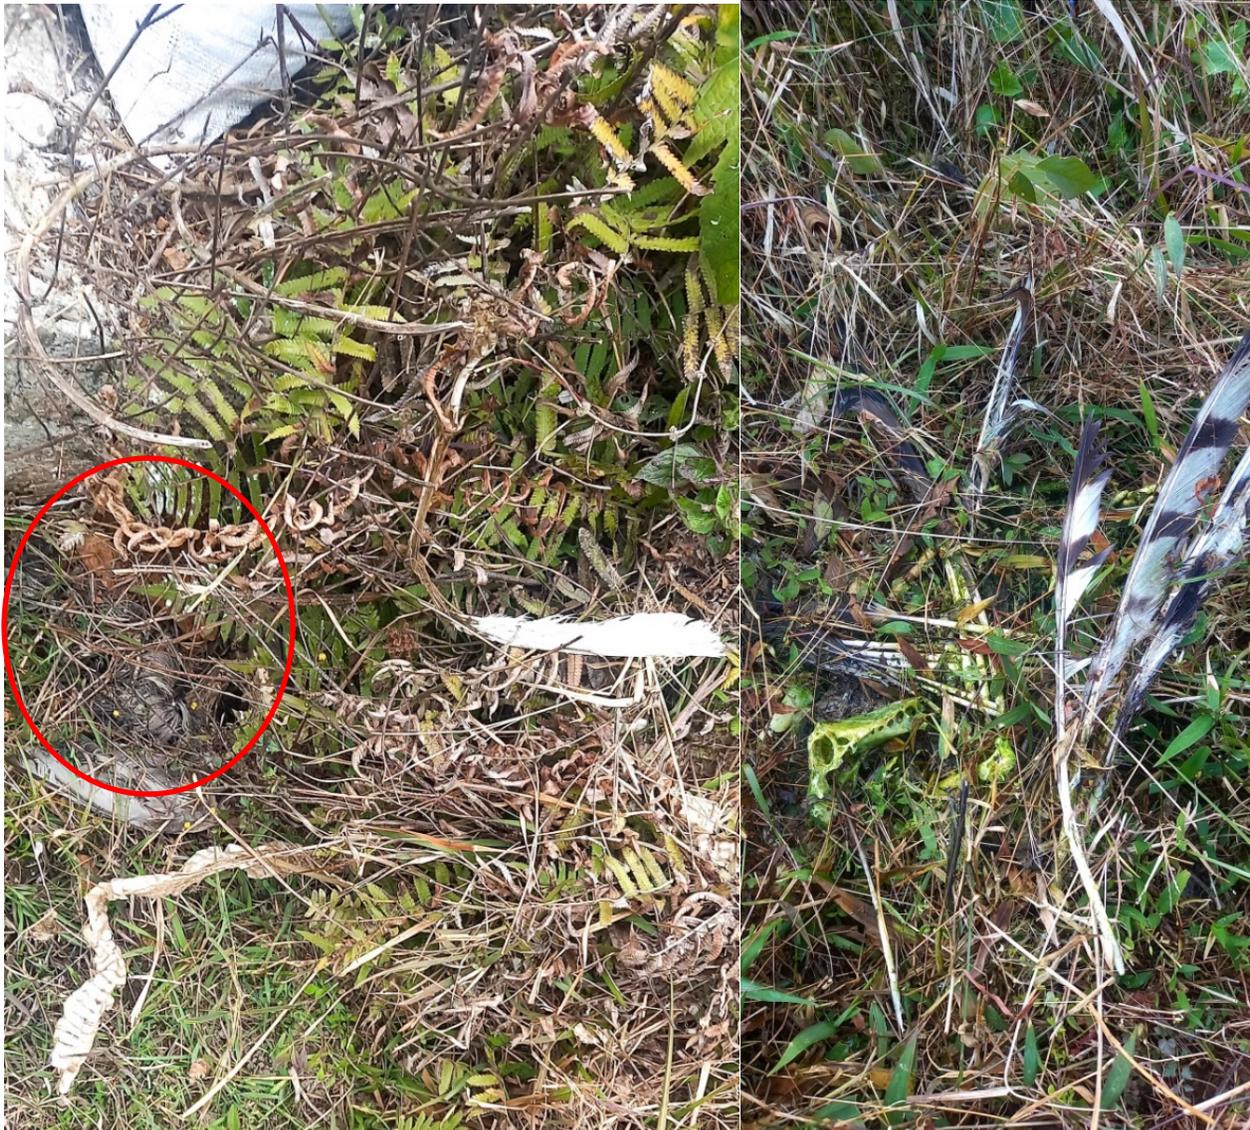
Photo: Dead bodies of Black-crowned Night Heron under the pole in Dipang (left) and Decayed bodies of Mountain Hawk Eagle under the electric poles in Panchase (right)
