# **Rufford Small Grant**

## **FINAL REPORT**

RESTORATION OF SMALL HEADWATER WETLANDS IN BULGARIA

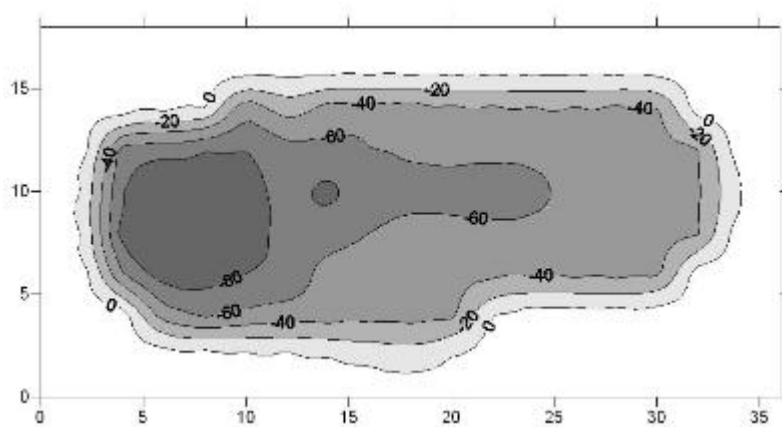
FIG.3: BATHOMETRIC MAP OF LAKE I. The depths mentioned are the “potentially achievable”; the real depths are approximately 30cm lower.

Bathometric maps have been constructed to 3 of the biggest lakes, subject to restoration (Annex I). The artificial dykes have been filled up and reinforced with sods and stones. After the winter period they are holding back the water, but the real effect (long lasting) will be monitored throughout the 2007 and the fill-up of the dykes will be repaired if necessary.

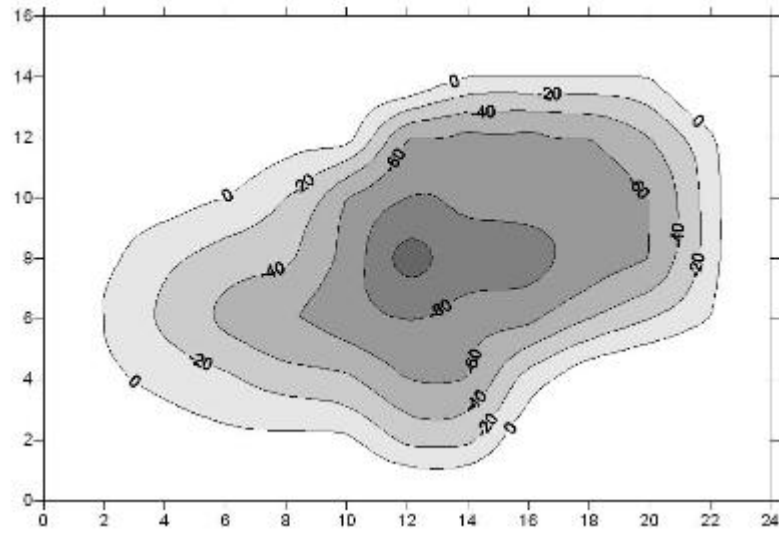
FIG.4: BATHOMETRIC MAP OF **LAKE II**. The depths mentioned are the “potentially achievable”; the real depths are approximately 30cm lower.

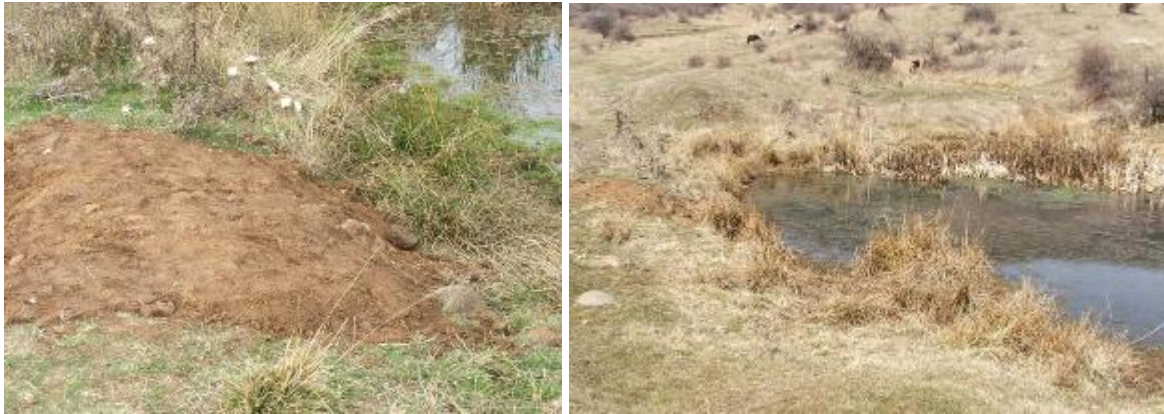
Pic. 4a): Damming of the ditch of Lake I.

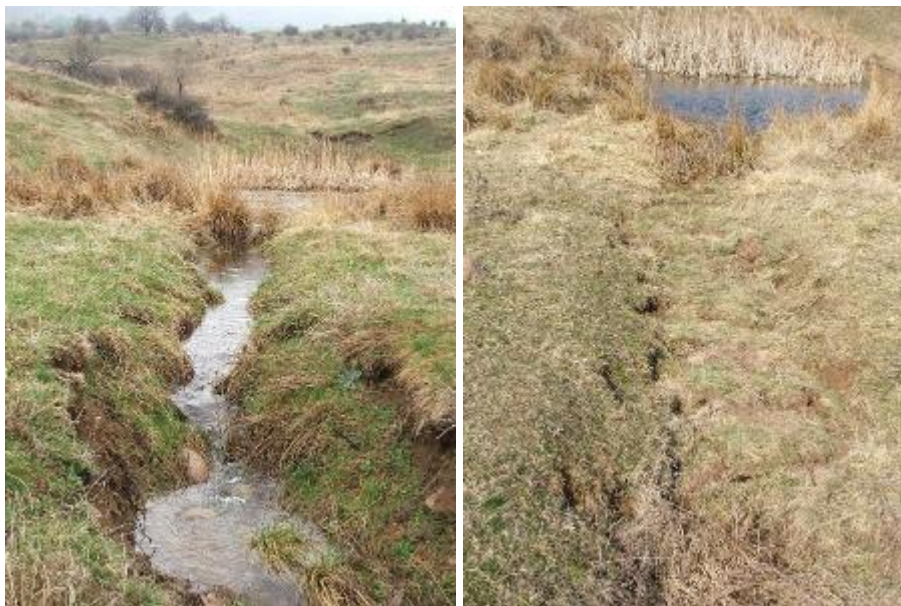
Pic. 4b): Damming of the ditch of Lake II.

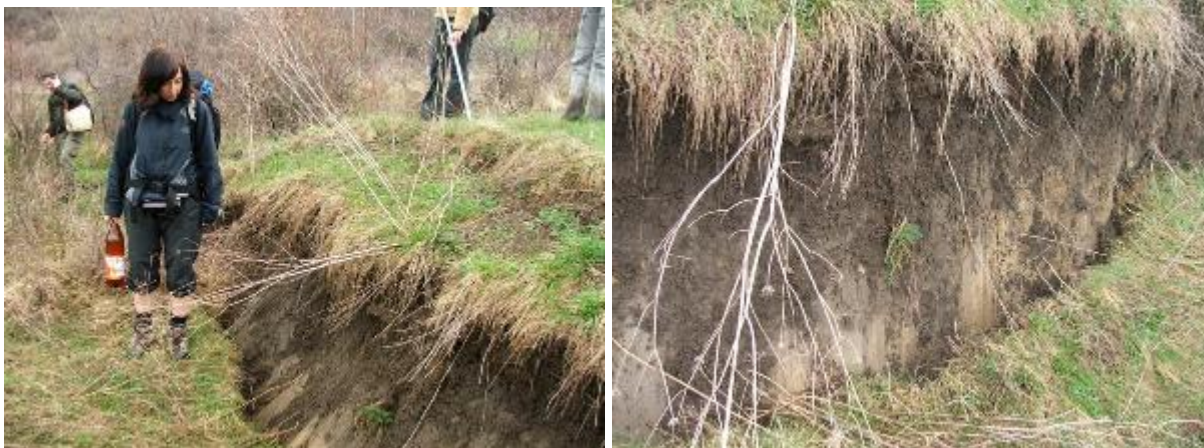
Pic.5: New landslide – Spring 2006

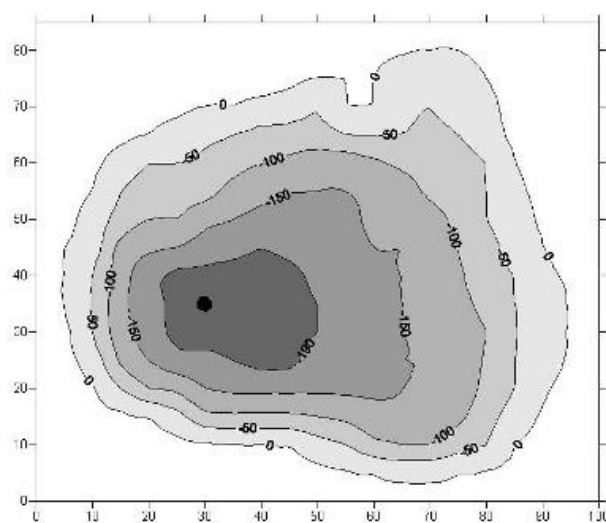
PIC. 8: BATHOMETRIC MAP OF THE BOYANA LAKE: The depths mentioned are the real depths.

We have collected the available historical data for the lake, including: ancient usage as water supply, construction of the main dike, usage for hydropower production (for the first HPP in BG), introduction of exotic fishes, etc. Mapping of the surface area and the bathymetry of the lake has been done. Vegetation mapping of the lake has not been done as more than 98% of the lake surface has been covered by pondweed, which was subsequently removed. Since November 2004 we have conducted regular (monthly/ to twice per month) monitoring of the lake, which includes basic chemistry, phytoplankton and zooplankton. Parts of the data were used to supply three MSc theses. Another MSc thesis, comparing the results of the Dragichevo and the Boyana lakes will be defended in September.

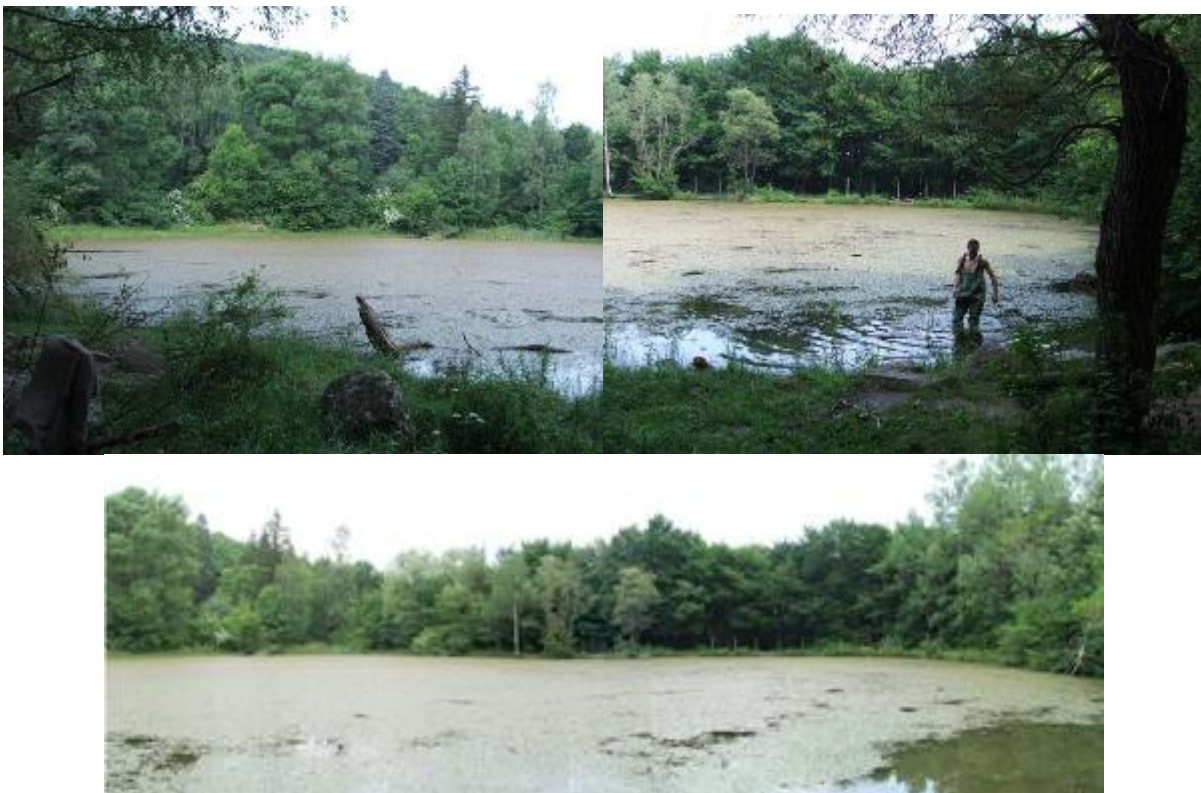
Pic. 10: Boyana Lake – before the removal of the pondweed – June 2005.

As we could not start the reinforcement of the main outlet of the lake (because of the rains), most of our efforts in 2005 have been concentrated on the manual removal of the pondweed. We have succeeded to remove more than 80 % of the pondweed from the deep portion of the lake. In addition to the pondweed we have removed a huge amount of tree trunks and smaller debris, including parts of furniture from the nearby hut (abandoned and partly destroyed).

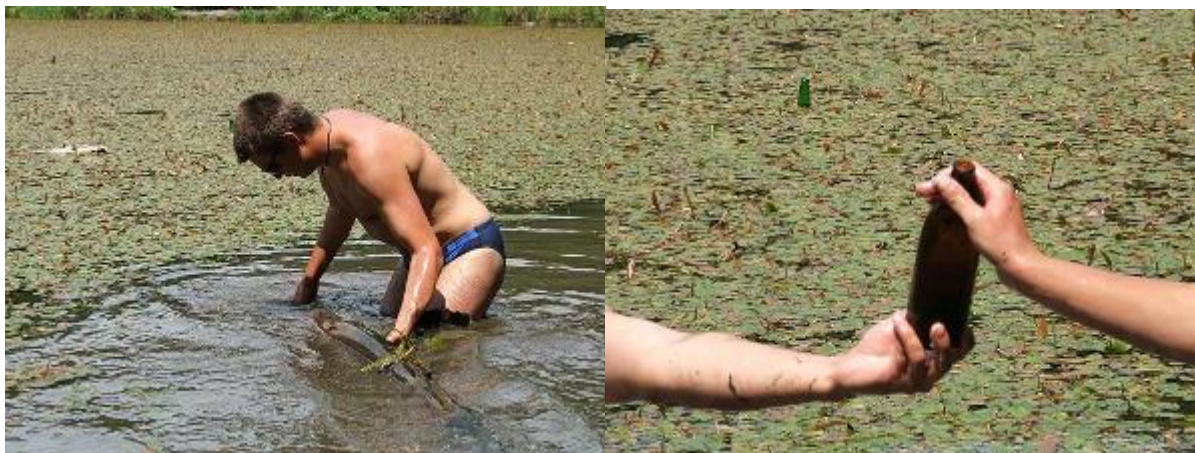
Pic. 11: Removal of debris and pondweed from the Boyana Lake – July/ September 2005.

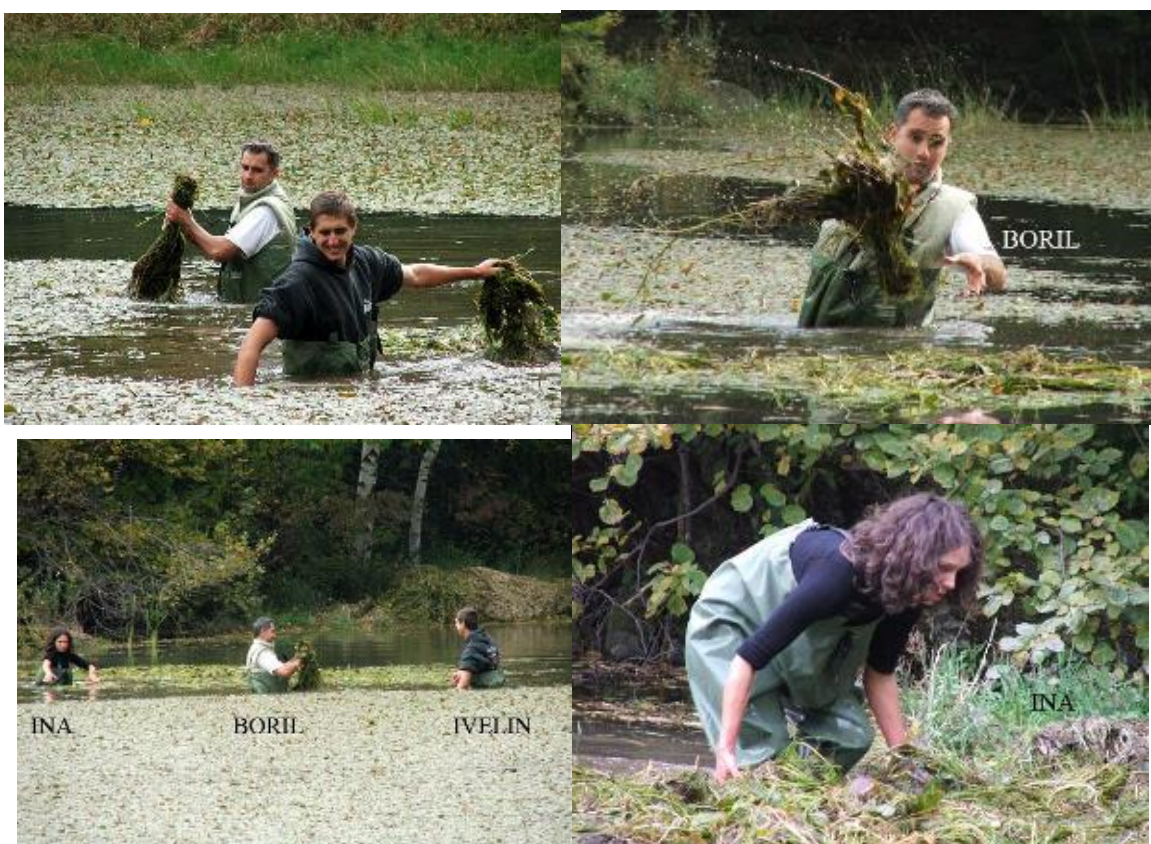
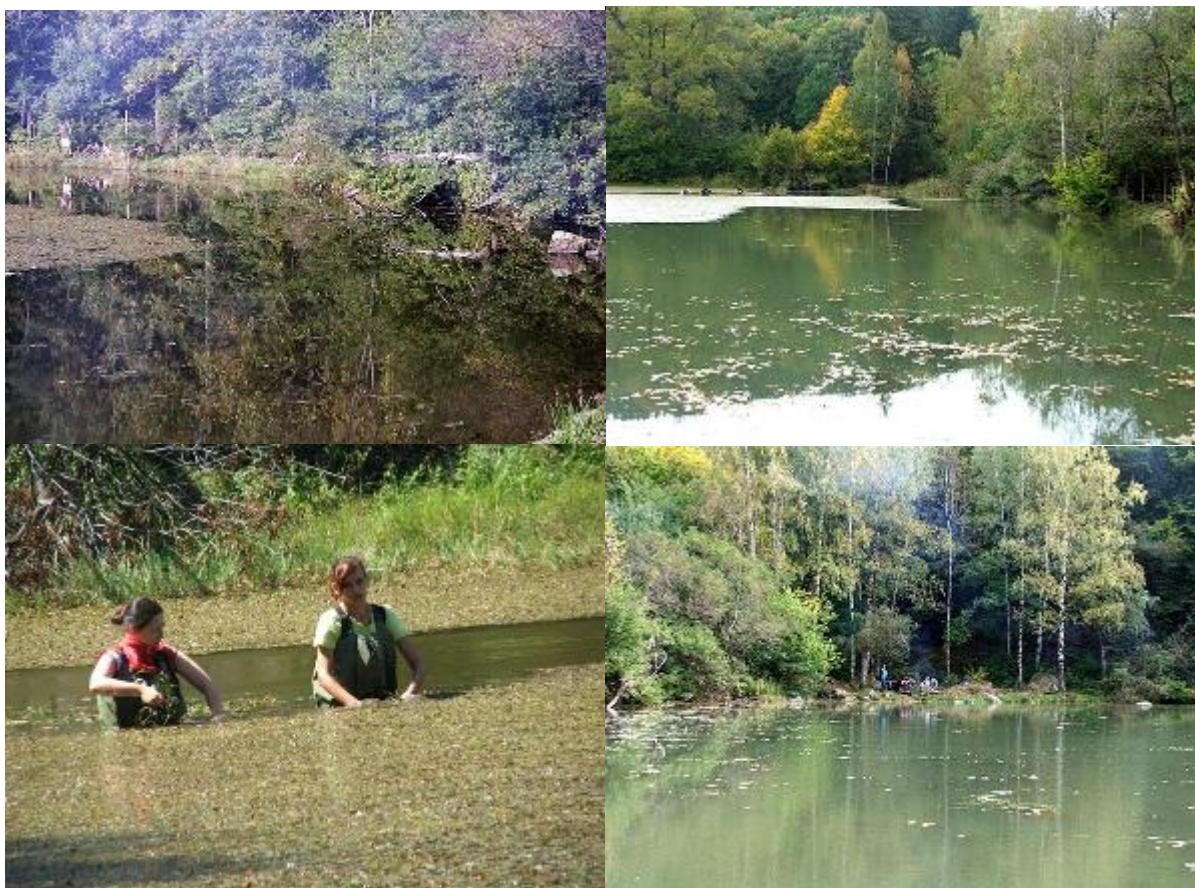
Pic. 12: Removal of debris and pondweed from the Boyana Lake July/ September 2005.

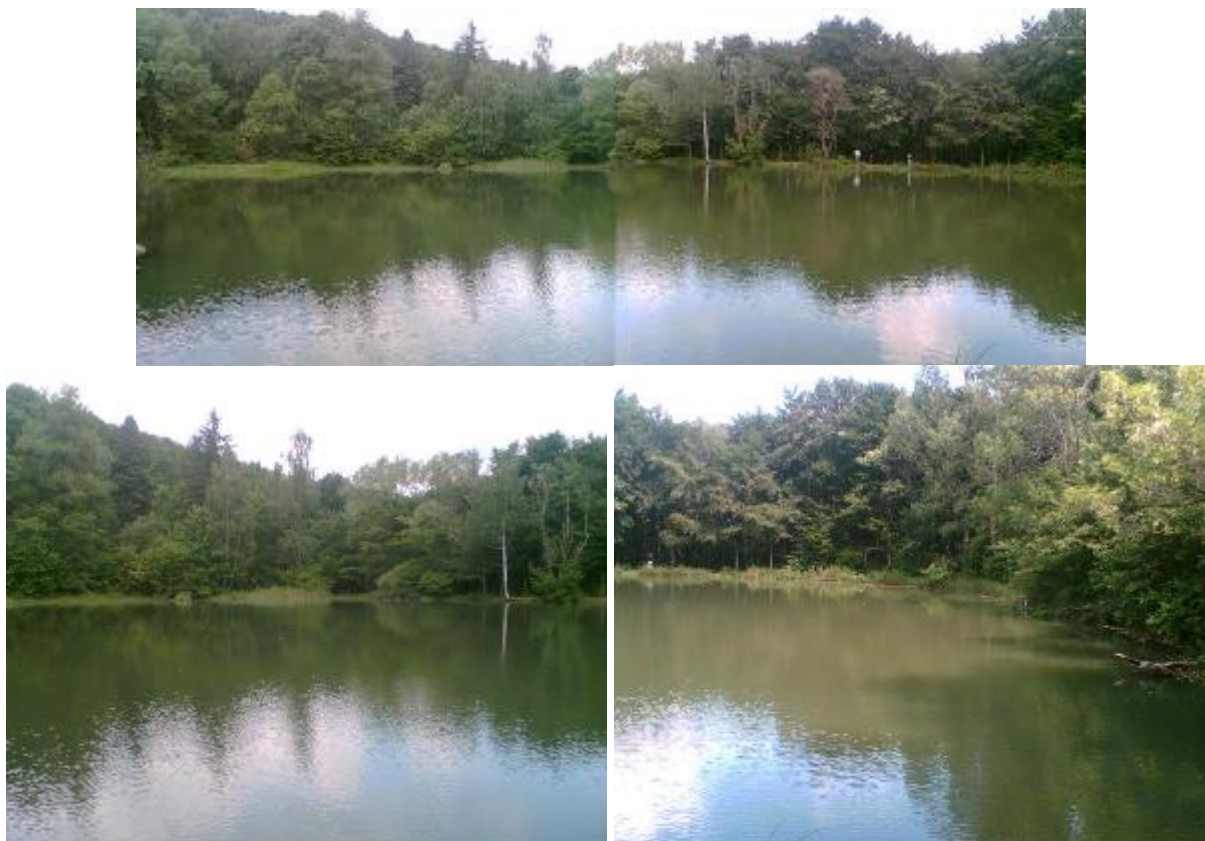
Pic. 15: Boyana Lake – After the removal of the pondweed and reintroduction of the grass carp – June 2007

In May 2006 we reintroduced the grass carp in the lake. A total of 150 grass carp and 50 tench specimens have been released into the lake. The grass carp has proven to be very efficient in controlling the amount of the pondweed in the lake, so we hope to achieve good sustainable results in the future. In June 2006 the pondweed in the lake have started to reappear again in some parts of the lake. After examining the causes of the rapid re-growth we found that the reason was in the high amount of the sunken macrophytes shoots to the bottom of the lake while they have been pulled out in the previous summer. By the end of June we cleaned up the bottom with garden rakes to collect the remaining of the shoots and continued the work by removing additional 15 % of the vegetation. The vegetation control was accomplished by volunteers, most of which were students from the Sofia University, NGO's volunteers, some people from the local communities and occasionally with the help of tourists passing by the lake.

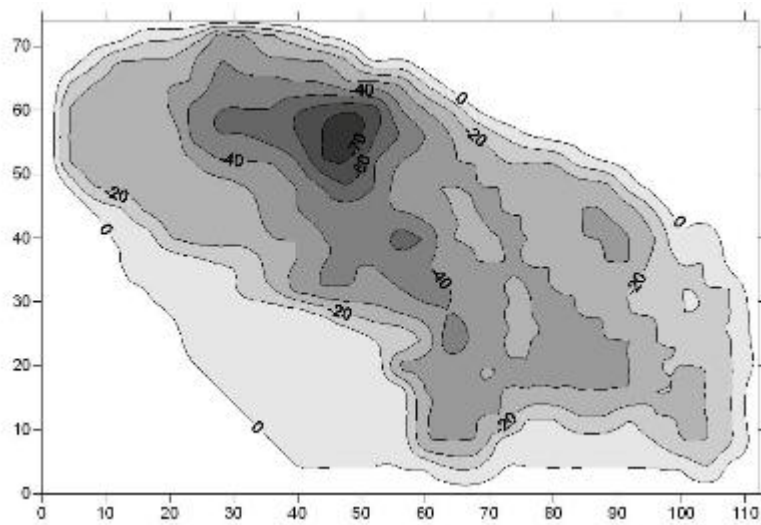
FIG.18: BATHOMETRIC MAP OF THE LOZEN LAKE: The depth figures are the real depths.

We have collected historical data about the lake. We provided map of the region and collected preliminary monitoring data. In 2006 we bathymetrically mapped the Lozne Lake.

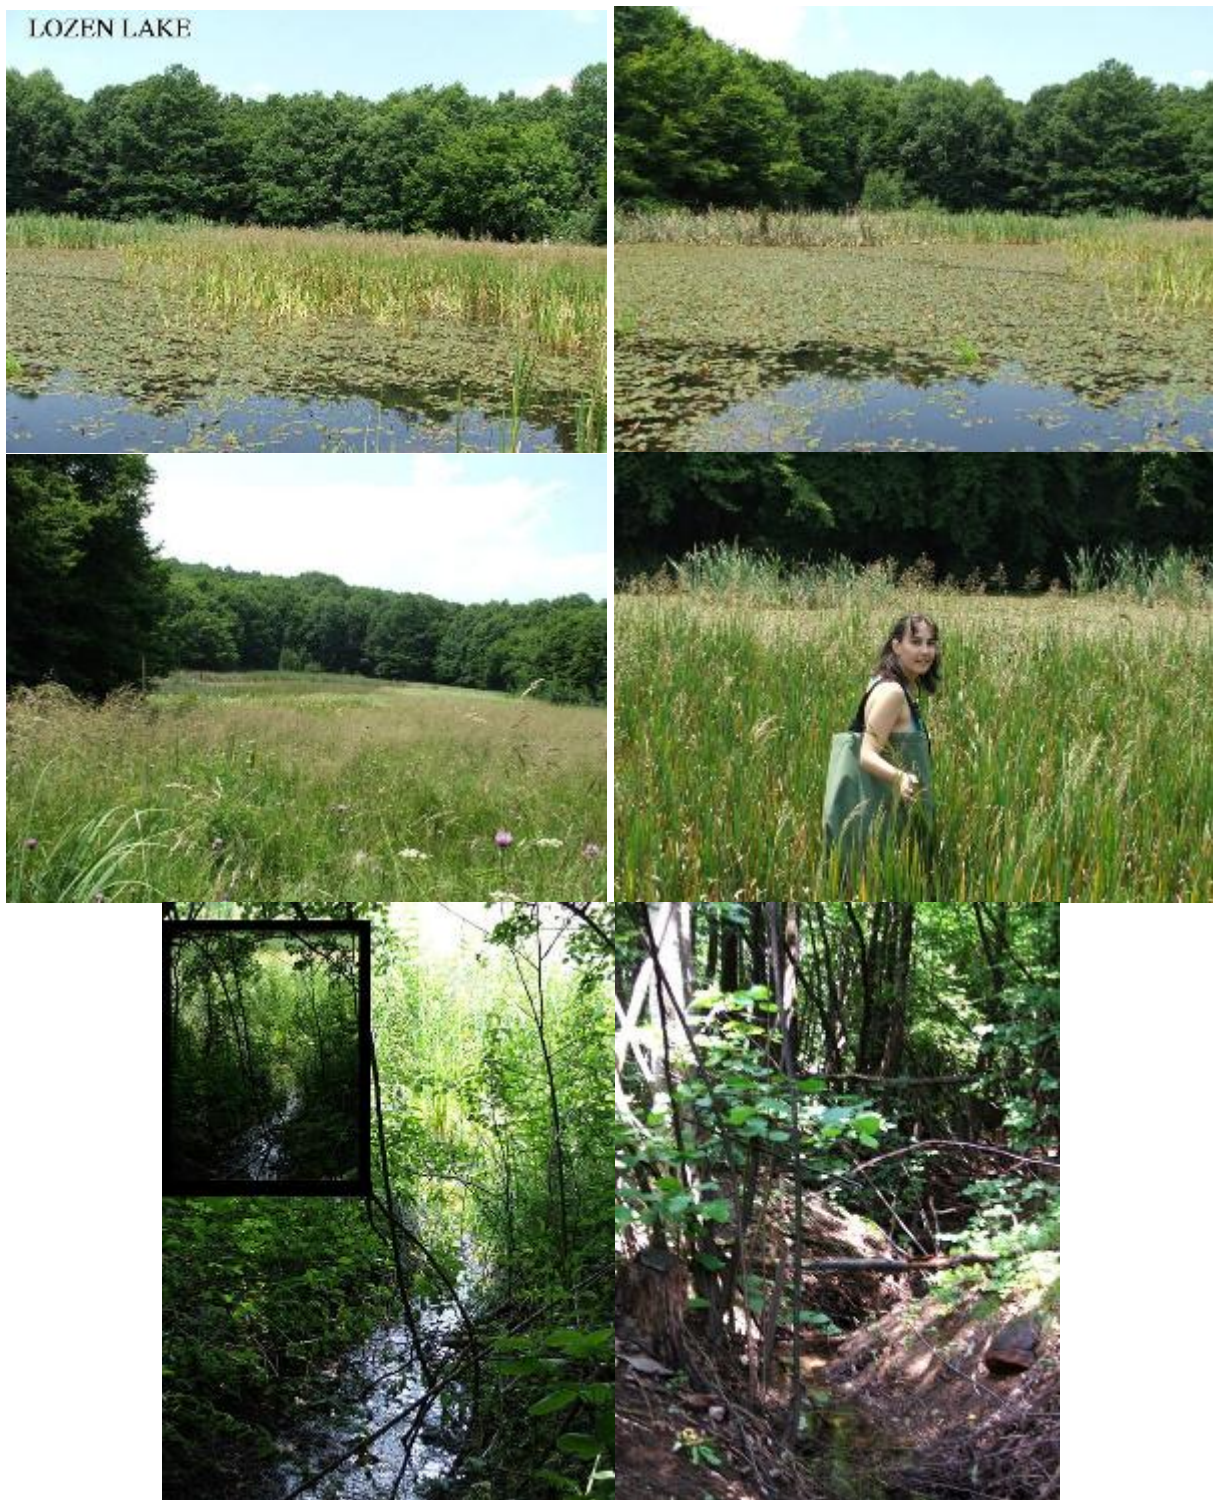
Pic. 19: The Lozen Lake – general view (up) and the ditch draining the lake (bottom) – July 2006.

We have stabilized the road crossing though the canal draining the lake. This part of the canal was filled up with soil, left to settle and reinforced with tree trunks and stones, so it can bear off the load of the trucks.
